TURBOCHARGER: DAMAGE PROFILES, CAUSES, AND PREVENTION

Technical information

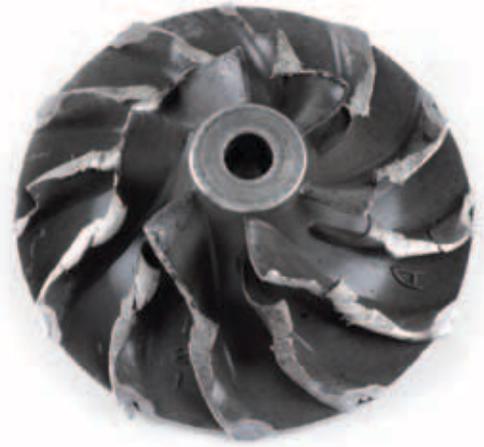
Fig. 1
Impeller after contact with housing

- The impeller and turbine wheel can strike the turbocharger housing on account of bearing damage (Fig. 1). This can be discerned from wear marks on the housing (Fig. 2).

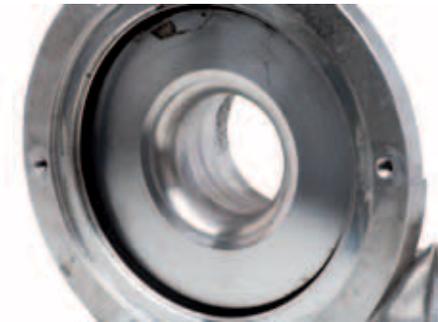
Fig. 2
Contact marks in the compressor housing

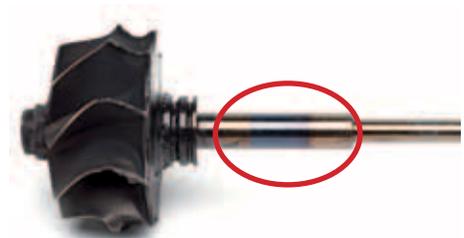
Fig. 3
Discoloration of the shaft shank

- The shaft shank exhibits clear discoloration (Fig. 3), which arises from friction and the resultant high temperatures between the shaft and the bearings. The cause of this is inadequate lubrication. If the temperature exceeds a certain level, the bearing material will become deposited on the shaft (Fig. 4) or the bushing might even become completely fused to the shaft.

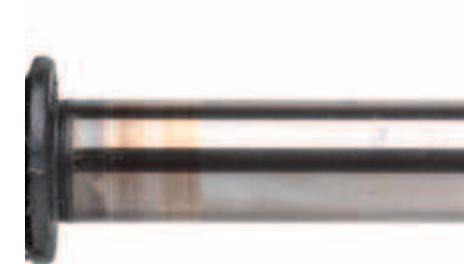
Fig. 4
Bearing material fused onto the shaft

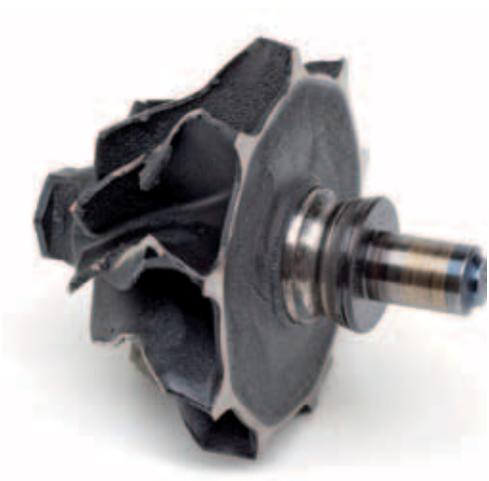
Fig. 5
Broken shaft shank

- A broken shaft shank (Fig. 5) is the result of operating the turbocharger for a prolonged time without enough oil. The shaft material can thus burn out and break.

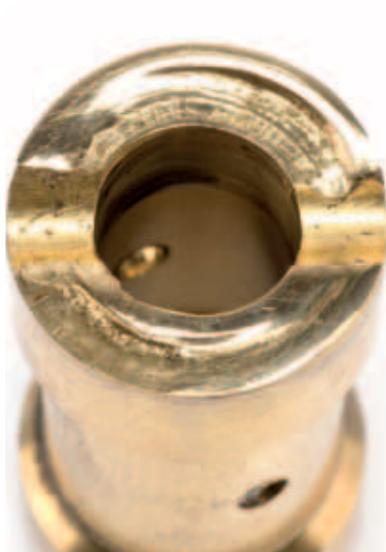
Fig. 6
Twisted bushing

- If bushings that are permanently incorporated in the bearing housing become fused to the shaft, the bushings might turn out of position in the bearing housing (Fig. 6).

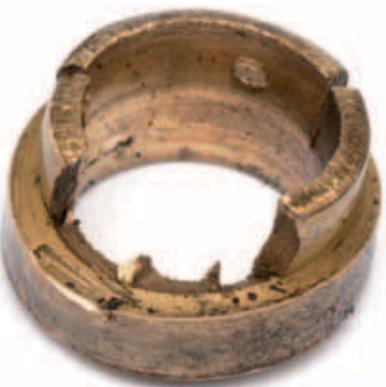
Fig. 7
Broken radial bearing

- The rotating assembly can exhibit a large imbalance owing to the contact with the housing, which might result in the radial bearing breaking (Fig. 7).

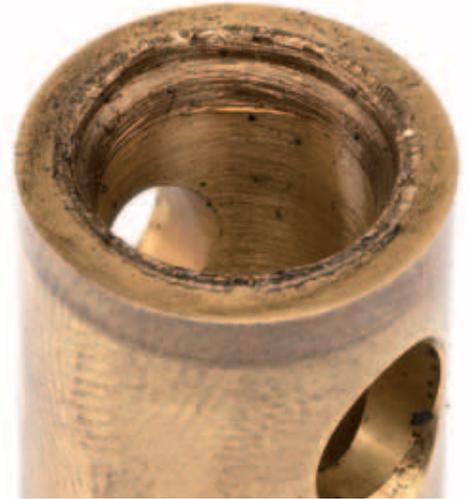
Fig. 1
Grooves in the radial bearing

- The smallest foreign substances in the oil cause grooves in the bushings (Fig. 1). The piston rings in the turbocharger can undergo serious wear. As worn piston rings can no longer adequately seal the turbocharger, the oil enters the turbine side, which can be discerned by increased oil consumption.

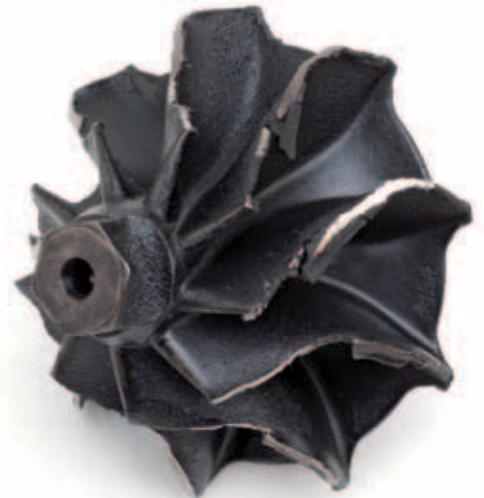
Fig. 2
Turbine wheel after contact with housing

- The bearing play of the rotating assembly increases due to the worn bushings. This leads to wobbling movements and causes the turbine wheel or impeller to come into contact with the housing (Fig. 2). The shaft might subsequently break off.

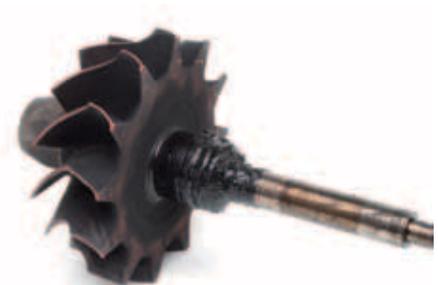
Fig. 3
Carbonized oil on the turbine side

- The bearing collar, i.e. the thrust washer of the axial bearing, exhibits grooves.
- Grooves or fretting marks are discernible in the axial bearing.
- Due to a blocked oil return line, the oil in the turbocharger can no longer flow off and is instead forced out to the compressor and turbine side. On the turbine side, the oil might then burn onto the shaft and coke (Fig. 3). Owing to the oil carbon layer, the bearing housing and the piston rings might be significantly worn off as a consequence.

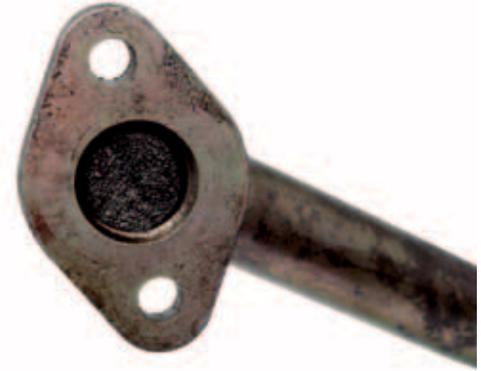
Fig. 1
Carbonized oil return line

- If the oil return line of the turbocharger is clogged (*Fig. 1*) or constricted by a kink, the oil can no longer flow out of the turbocharger (*Fig. 2, diagram B*). A possible cause for clogged oil return lines is the coking of the return line, which might be due to missing heat shields, a poorly routed return line, heat soak, inadequate oil quality, or the use of liquid sealants. As the turbocharger is still supplied with oil from the engine circuit, the oil then escapes to the turbine or compressor side.

- The engine must only be filled to the specified maximum oil level.
- Only engine oils specified by the vehicle or engine manufacturer may be used.
- The oil return line must be routed exactly as in the original state. In addition, it must be ensured that all heat shields are attached.
- The oil return line and the connections to the crankcase must be checked for continuity. We generally recommend replacing the line and the connecting piece.
- The crankcase ventilation must be checked and replaced, if necessary.
- The piston and piston rings must be checked for wear and replaced, if necessary.
- A new charge air cooler and air filter should always be installed when replacing the turbocharger. In addition, an oil change including oil filter replacement must be carried out.

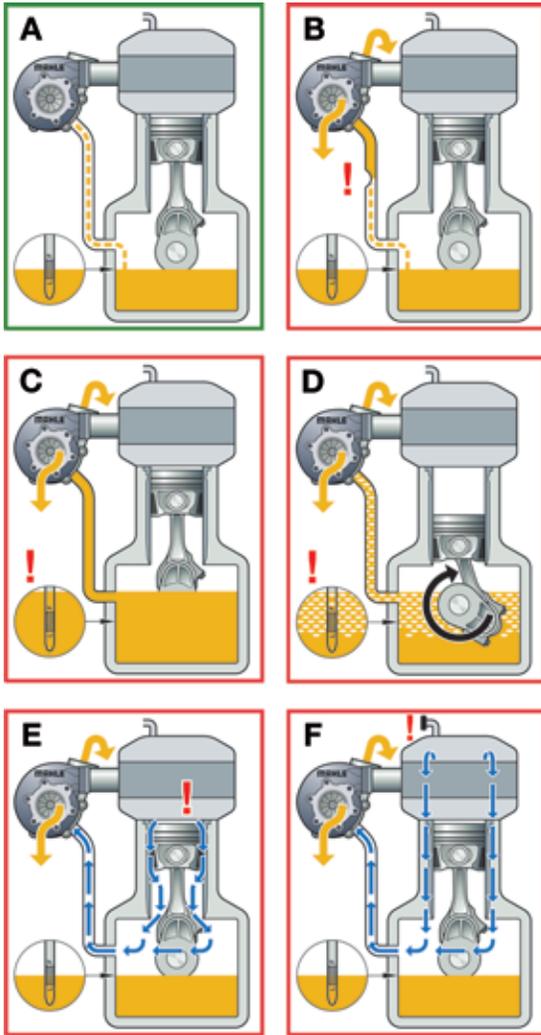
Fig. 2
Oil leakage at turbocharger. Diagram A shows the optimum state.

- If the engine is supplied with too much oil, the oil can no longer flow back out of the oil return line into the oil pan (*Fig. 2, diagram C*). The crankshaft also splashes up the oil. This results in the oil foaming, which forms an additional barrier for the returning oil from the turbocharger (*Fig. 2, diagram D*).

- If the pressure in the crankcase is too high—either because of too high blow-by (*Fig. 2, diagram E*) or due to blocked crankcase ventilation (*Fig. 2, diagram F*)—, this pressure will also be transferred to the oil return line of the turbocharger. The oil drainage from the turbocharger is thus hindered, and the oil escapes from the turbine or compressor side.

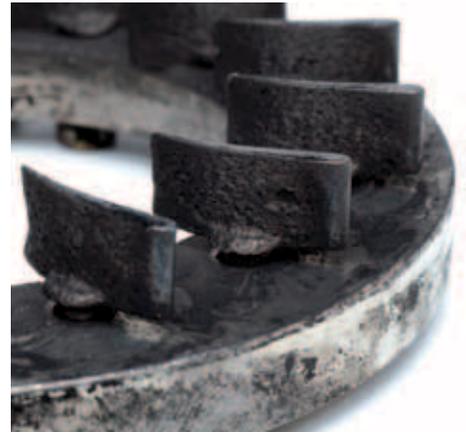
Fig. 1
Damaged air guide plates of the VTG unit

- On account of previous damage, foreign substances from the engine or the exhaust manifold can damage the gas entry edges of the turbine wheel.
- The air guide plates of the VTG unit are damaged and bent (Fig. 1), leading to a significant power loss.
- Foreign substances in the intake air result in damage to the impeller (Fig. 2). The vanes might become completely worn as a result. In addition, the intake passage of the compressor housing might be damaged (Fig. 3).
- The impeller might be damaged by condensation frozen in the intake section. Damage to just one vane is characteristic of this cause: owing to the high speeds, the ice particles burst when encountering the first vane, with no other vanes being damaged (Fig. 4).

- If a valve is torn off or the piston rings fracture, for example, these parts come into contact with the guide vanes of the VTG unit and the turbine wheel via the exhaust manifold.
- Both a leakage in the intake section and a contaminated or defective air filter can be the cause of penetration by foreign substances in the intake section.
- In winter, ice can form through condensation in the intake section.

- The leak tightness of the intake section must be guaranteed.
- After working on the intake section, it must always be ensured that no loose parts remain there.
- The air filter must be replaced as specified by the manufacturer, and the air filter housing as well as charge air line should be cleaned by suction.
- Only driving short distances should be avoided.

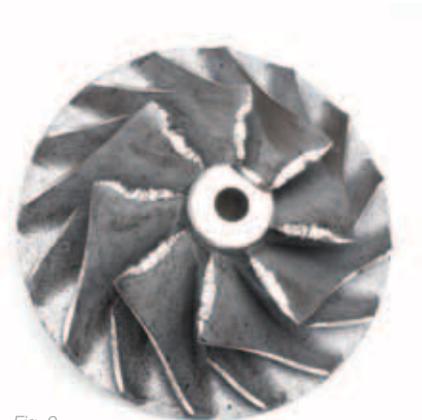
Fig. 2
Impeller damaged by foreign substances

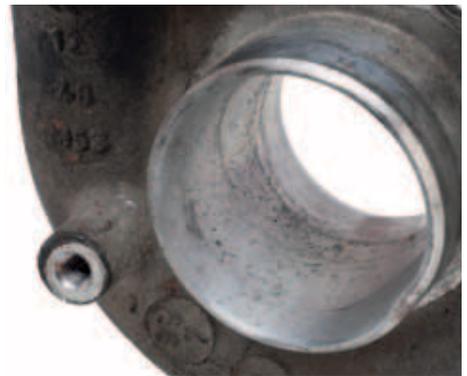
Fig. 3
Foreign substance impact in the intake passage of the compressor housing

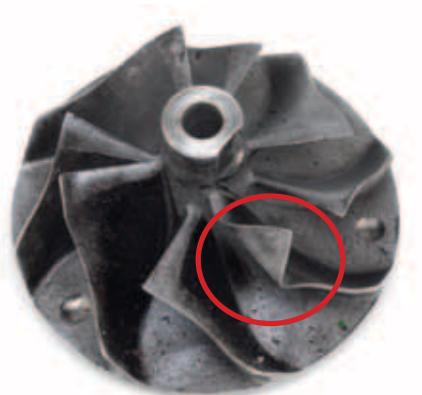
Fig. 4
Only one vane of the impeller damaged

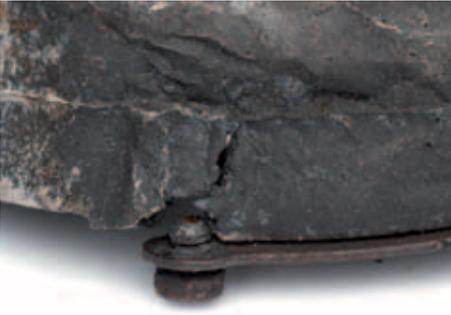
Fig. 1
Crack in the turbine housing

- Cracks in the housing of the turbocharger (*Fig. 1*).
- Oil lines can become coked: If the supply line is carbonized, the turbocharger will not be sufficiently supplied with oil. If the return line becomes coked, the oil can no longer flow off and oil is forced out of the turbocharger (see also section 4 “Oil leakage at turbocharger” on page 10).

- The temperature level has changed due to tuning.
- Combustion faults have occurred in the engine.
- The engine was turned off while still hot.

- The turbocharger may only be installed in the specified vehicles.
- The turbocharger may only be installed and operated in the original state as supplied. Technical modifications are not permitted.
- The engine must always be cooled down at moderate speeds after high stress, such as driving at full load.

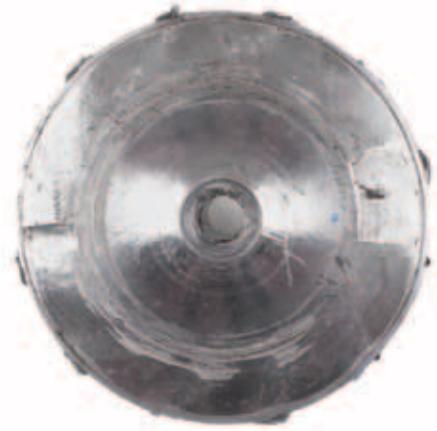
Fig. 1
Dents on the rear of the impeller

- Small dents can be seen on the rear of the impeller (Fig. 1). The material (mostly aluminium) has deformed permanently due to high centrifugal forces at overspeeds. It begins to flow and the outer diameter increases.
- If the speeds increase further, the impeller can come into contact with the housing and/or break apart (Fig. 2).

- The maximum permissible speed of the turbocharger was exceeded due to tuning.
- The VTG air guide plates become blocked in the position for low speeds due to carbonization. If the engine speeds are then increased, the turbocharger enters the overspeed range.
- The pneumatic or electric control is defective or leaking.

- The turbocharger must always be left in the original state as supplied.
- The turbocharger may only be installed in the specified vehicles.
- The engine must always be cooled down at moderate speeds after high stress, such as driving at full load.
- Only engine oils specified by the vehicle or engine manufacturer may be used.
- The maintenance intervals according to the manufacturer's recommendations should always be complied with.

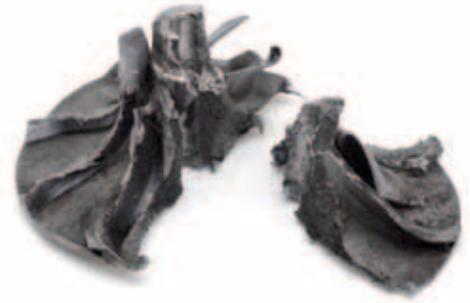
Fig. 2
Broken apart impeller
